Canal District Historic and Cultural Resources Report

In 2021, the City of Savannah solicited proposals to identify historically significant structures, development patterns, and neighborhood boundaries; and provide documentation and recommendations for the protection of historic resources within the Canal District (Figure 1). Ethos Preservation, a local, women-owned small business, was selected to complete the project. This report builds upon efforts previously undertaken by the City of Savannah as part of the Canal District Master Plan, where the need for a cultural and historic resource survey of the area was identified to support: 1) the reuse of the Water Works building as a community market and business center (Action Step 7); 2) the curation and construction of the West Savannah Heritage Trail (Action Step 8); and 3) the revision of the Zoning Ordinance to establish a Canal District Overlay District (Action Step 18).

The bounds of the study area were determined by the community-selected boundaries established in the Canal District Master Plan. Of the 335 buildings within the study area, 192 were determined to be 40 years or older and were subsequently documented through th

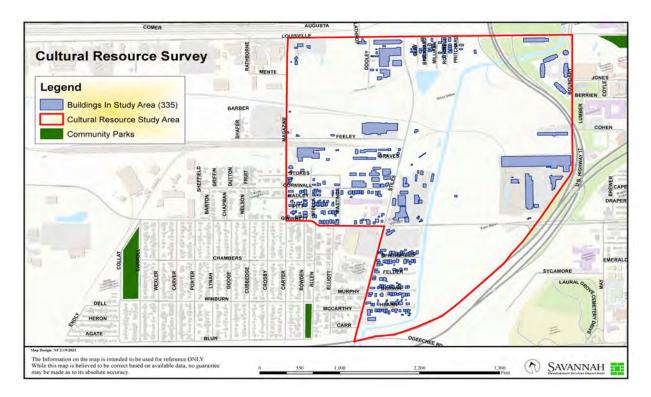
Figure 1: Canal District Boundaries as outlined in the Canal District Master Plan, with buildings in the study area shaded in purple.

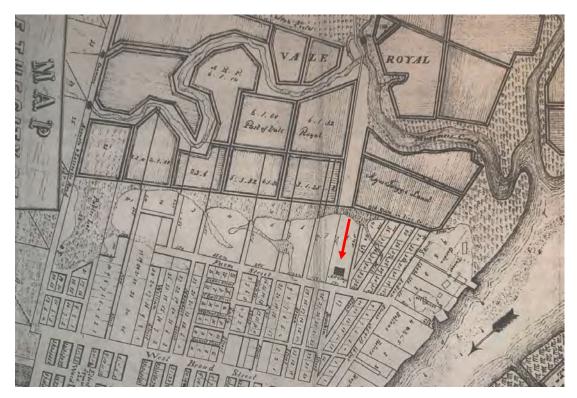
Figure 2: circa 1800 Map of Savannah, with west to the top and the Savannah River on right. Note the Clay House at the end of Joachim (Bay) Street (red arrow) (Low Land and the High Road 3). (Georgia Historical Society)

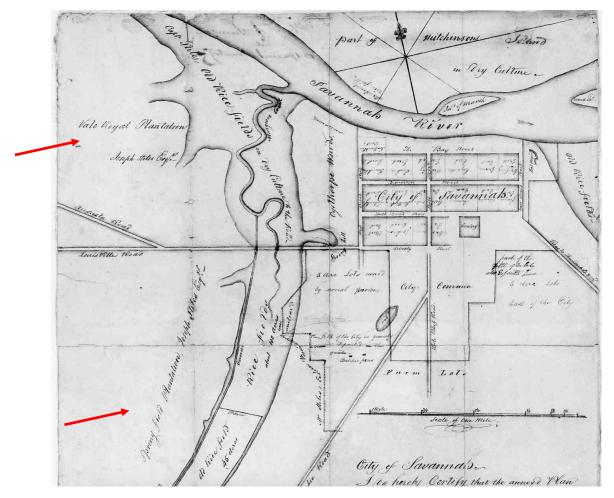
Figure 4: Excerpt of the 1825 Map of Savannah showing Joseph Stiles ownership of Springfield and Vale Royal Plantations and their relation to the city of Savannah. Note the location of Spring Hill, where the rice field basin extends east at Louisville Road and West Broad Street (Martin Luther King, Jr. Boulevard)

Clay died in 1804. By 1806, Springfield Plantation had passed to his son-in-law, Joseph Stiles (Figure 4). Stiles inherited the Clay House (Figure 3) and land (Figure 4), where he grew cotton and rice for 32 years (Golson). Stiles diversified his interests, developing brickmaking facilities, rice mills, and early railroad infrastructure, made possible by the use of enslaved labor. At the time of his death in 1838, it was recorded that Stiles owned 124 enslaved persons (Brockington and Associates 28-29). The vast real estate assets of the Stiles estate including Vale Royal, Springfield, Green Island, and several other properties were left to his large family of ten children and a widow (his second wife). Records indicate that prior to his death, a five-acre tract of land called the "Brickyard" on the northwest corner of the Vale Royal Plantation was deeded to his daughter-in-law Elizabeth Stiles, wife of Williams H. Stiles, and their children (Granger, 467).

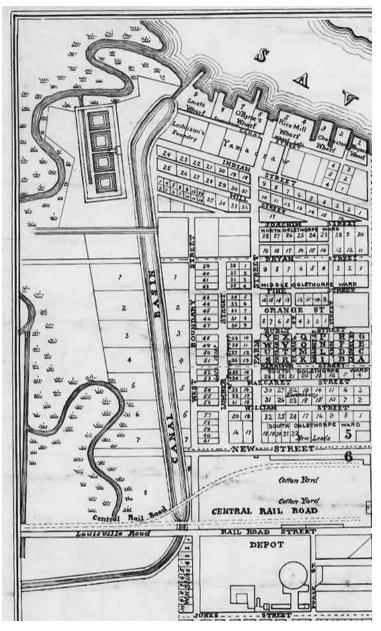
Figure 7: Excerpt of the 1856 Map of the City of Savannah showing the Springfield Canal Basin and the early division of adjacent lots. Note Musgrove Creek which meandered west of the Canal Basin (Hargrett Rare Book and Manuscript Library).

where the Brickyard neighborhood is located today (Figures 7 and 8). Used by the timber industry, it is believed that these were filled at the time of the Springfield Canal's diversion into the Savannah-Ogeechee Canal. The diversion of the Springfield Canal led to the complete loss of Musgrove Creek and the loss of a large portion of the manmade Springfield Canal (Spracher 25).

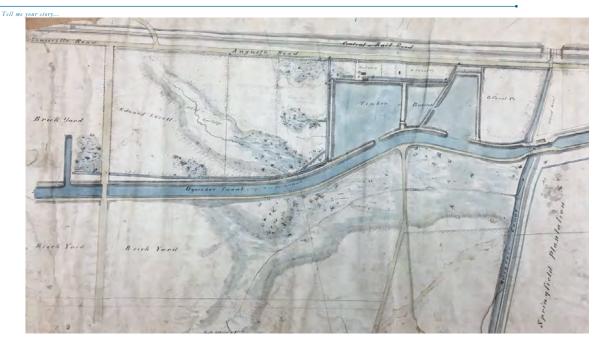
Figure 8: 1878 Map showing the brick yards south of Louisville Road (also noted as Augusta Road). Land owned by Edward Lovell sits adjacent to an area noted as "garbage." "Timber Basins" extend off of the Savannah-Ogeechee Canal where the modern day Brickyard community exists (City of Savannah Municipal Archives).

The industrial activities that began during the plantation era in the survey area continued to drive the economy. Brick making operations in the area are a notable industry that carried over after the dissolution of the rice economy (Figure 8). A laborious task, enslaved persons are credited with making many of Savannah's early bricks. Located at Spring Hill, where Liberty Street turned into Louisville Road, Millens Brick Yard was one such business, as mentioned in an advertisement which attempted to locate an enslaved person who had fled captivity, dated May 3, 1821:

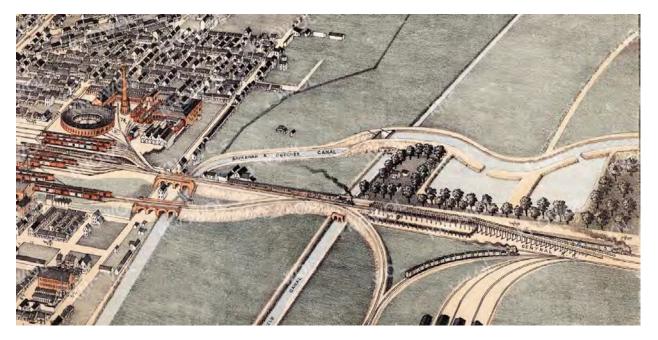
Figure 9: Excerpt from the 1891 Bird's Eye Map of Savannah, looking south, which shows the Savannah-Ogeechee Canal meandering beneath the railroad viaducts and the Springfield Canal running north-south at center. Note this image's depiction of the timber basins where the present day Brickyard neighborhood is located (Georgia Historical Society).

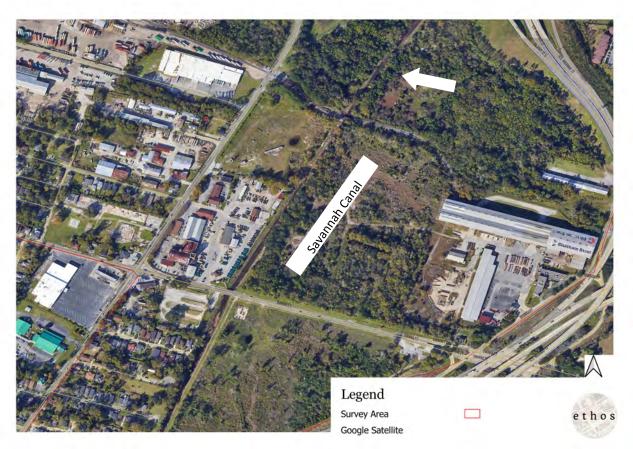
Figure 10: Map of Savannah Canal on the east side of the Arena site (Google Satellite).

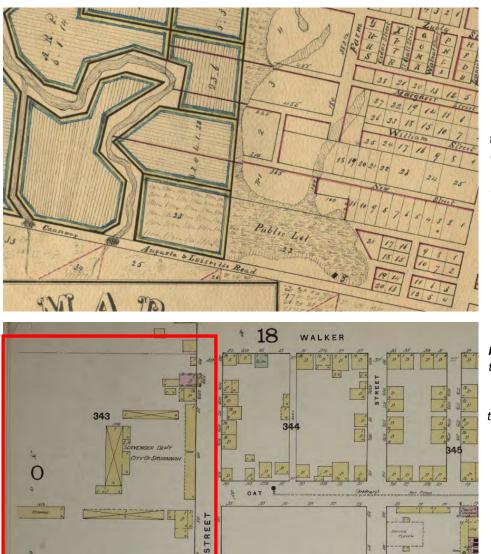
Figure 11: Excerpt from circa 1812 Map of Savannah by Col. Mossman Houston showing the location of a "Public Lot" adjacent to agricultural lots north of Louisville Road where present day Boundary Street is located (Digital Library of Georgia).

A lesser known history is that of the "Scavenger's Lot" on West Boundary Street. A city dump of sorts, records show that the site existed as early as 1812 (Figure 11). The lot served as the unloading point for debris and dead animals removed from City streets gathered by municipal enslaved labor. By 1888, the lot housed two stables, two barns, a cart shed, a dwelling, and an office west of West Boundary Street. While unconfirmed, it is possible that the enslaved scavengers resided in the dwelling at the Scavenger Lot (Brooks). The lot and its associated buildings existed as late as 1898, although the buildings had been abandoned by this date (Figure 12).

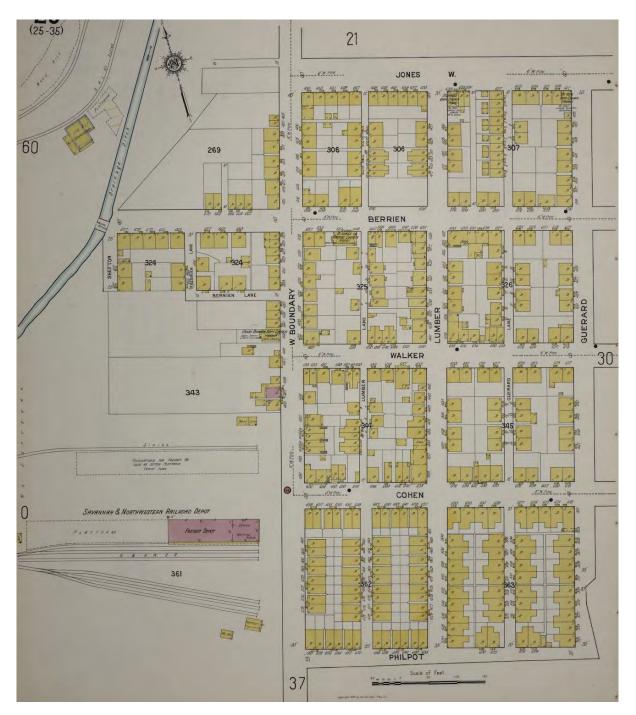
Figure 16: 1916 Sanborn Map showing the Savannah & Northwestern Railroad Depot (left, pink) erected in place of the City Scavenger Lot and the numerous houses east and west of Boundary Street, none of which remain. West of the area historically known as Frogtown, the name Water Works was also applied to this area. Note the wooden bridge over the canal at the end of Berrien Street and the frame "commissary" building sitting on the northwest corner along a railroad spur (Library of Congress).

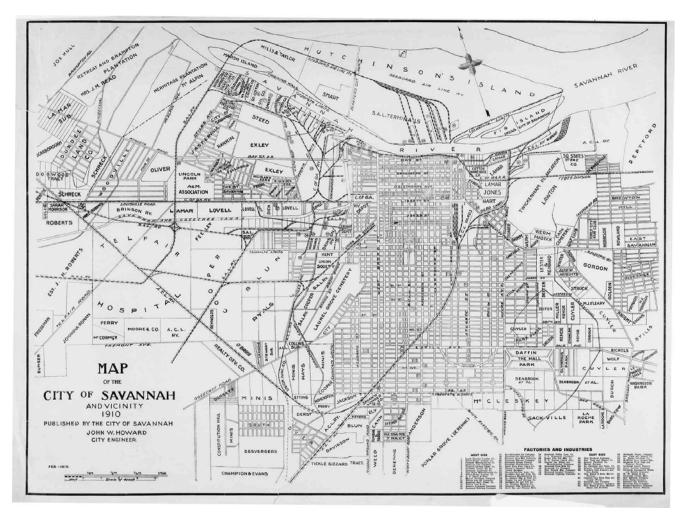
Figure 17. *City of Savannah map published by City Engineer John Howard in 1910 (University of Georgia Hargrett Rare Book and Manuscript Library).*

development of the city of Savannah, meant the area was a location of choice for industrial businesses. The 1910 map by Savannah City Engineer John Howard (Figure 17) shows the crisscross of railroad lines throughout the survey area, numbered dots for factories and industries, and tighter streets laid out for residential development.

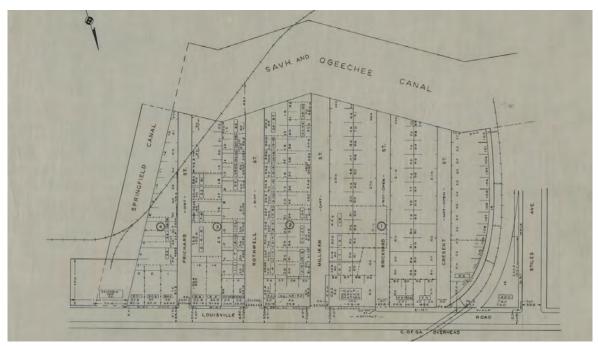
Figure 19: Williams Ward in 1939, as recorded by the Savannah Cadastral Survey. Pritchard, Rothwell, and Millikan Streets are noted as dirt streets whereas Brickyard and Crescent (Clay Street today) are shown as "Not Open" (City of Savannah Municipal Archives).

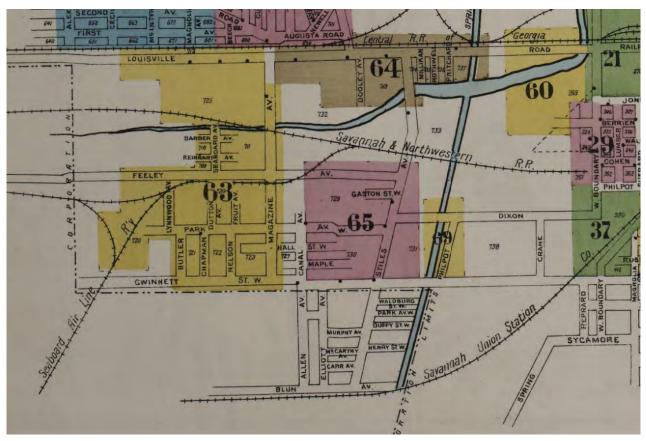
Figure 20: Excerpt from the 1916 Sanborn Map index showing the area that had developed east and west along Stiles Avenue by this date. Nearly all the street names within the survey area have different names today, with the exception of those associated with the Brickyard neighborhood (area #64 in brown) (Library of Congress).

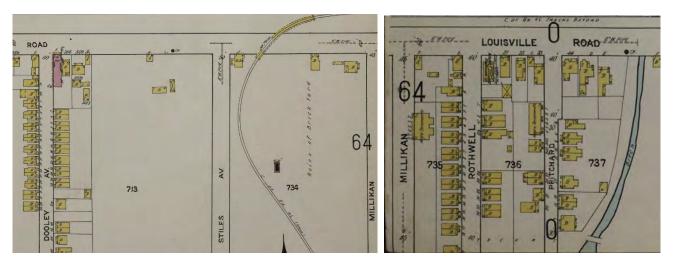
Figures 21 and 22: Brickyard neighborhood in 1916. Note the "ruins of brick yard" and railroad spur at the southeast corner of Stiles and Louisville Road (left). Excerpts from the 1916 Sanborn Map for Savannah (Library of Congress).

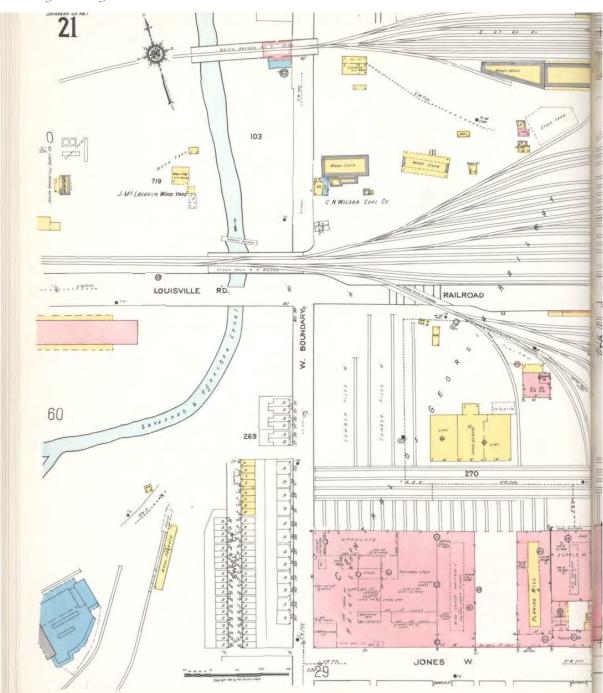
Figure 23: 1955 Sanborn Map showing the growth of the Central of Georgia Railway buildings east of Boundary Street and housing that sat west of Boundary Street that was demolished for the I-16 on ramp (Library of Congress).

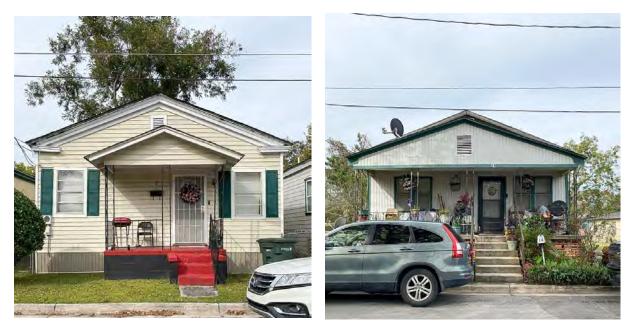
Figures 29 and 30: Circa 1910 houses on Rothwell Street in Brickyard that were once duplexes which have since been converted to single family homes. Note the main entrance placed off center adjacent to where a second entrance existed previously. The second entrance was likely removed when the houses were last rehabilitated.

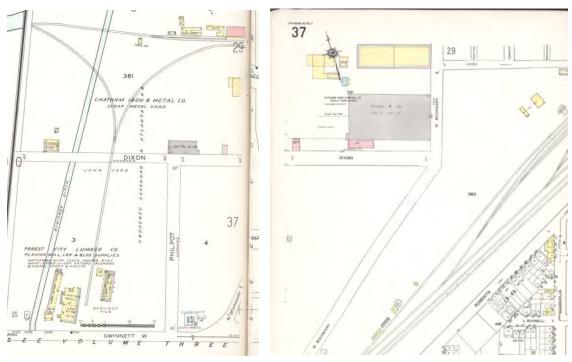
Figure 36: Excerpts from the 1955 Sanborn Map showing the original location of Chatham Iron & Metal Company (Chatham Steel) along Dixon Street, which previously connected Stiles Avenue to W. Boundary Street. Note the Forest City Lumber Co. and Philpot Street to the south (Library of Congress).

histories have told of Gus Matthias' store at the northwest corner of Stiles Avenue and Gwinnett Street and Mayor Jones' barber shop on Stiles Avenue. Kempers Market was owned by a Jewish man and the Matthias store was owned by a Greek man. Other early remembrances record that the land where the Cloverdale community sits today, just south of the survey area, was home to the Starland Dairy cattle farm (Orage). One of the largest anchors of the survey area, Chatham Steel, developed in the early twentieth century along Dixon Street, which formerly connected Stiles Avenue with West Boundary Street (Figure 36). Today, the only building that remains from this era at Chatham Steel is believed to be the metal warehouse closest to West Boundary Street (shown in gray below).

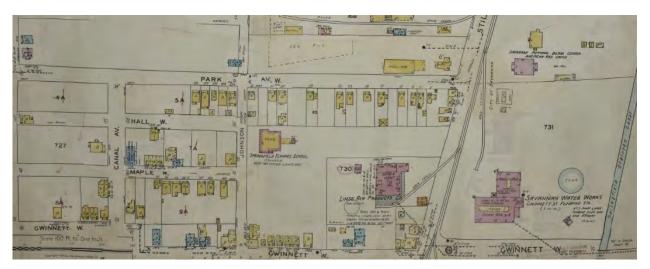
Figure 39: 1950 Sanborn Map excerpt from page 65 showing the area north of Gwinnett Street on either side of Stiles Avenue. Blue buildings represent concrete block building infill. Note the construction of the Springfield Terrace School east of Johnson Street (Hastings Street today) (Library of Congress).

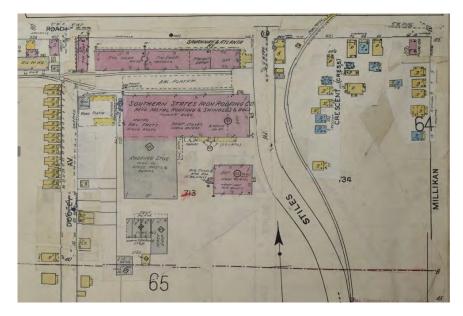
Figures 40 and 41: Excerpts from the 1950 Sanborn Map Page 64 showing the Brickyard neighborhood on either side of Millikan Street (top is west, bottom is east) to include concrete block dwellings in blue. Clay Street is noted as "Crescent (Cress)" (Clay Street today) and Brickyard Street is not shown although one house faces its vicinity. Notably the area has dense house development and a masonry ice house on Louisville Road (Library of Congress).

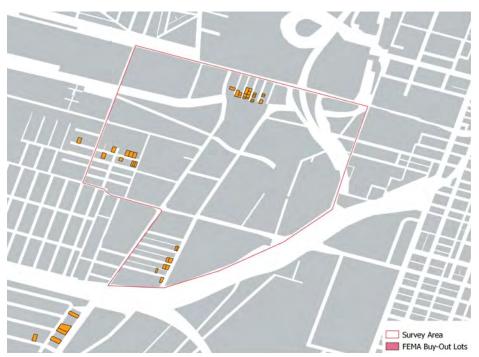
The continued use of federal funds by the City of Savannah to remove structures in the name of progress in recent decades through the Federal Emergency Management Agency's (FEMA) Hazard Mitigation Grant Program funds has meant that the City has purchased flood-prone structures as a means of "managed retreat" from flood-risk areas. A recent study of national data of the voluntary buy-out program showed that buy-out properties tend to be concentrated in low-income neighborhoods of color (Elliot, et. all.) Statistically, these neighborhoods have endured decades of systematic racism and are more likely to accept the buy-outs at a greater rate. A total of 36 structures have been purchased and demolished in the survey area with this program, mostly impacting the Brickyard neighborhood (FEMA) (Figure 42).

Figure 42: Map of FEMA Buy-Out lots in the survey area (SAGIS).

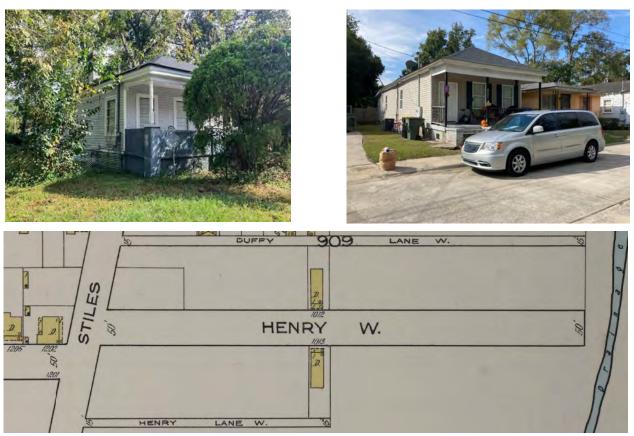
Figures 45 and 46: 1012 Hearn Street (top left) and 1013 Hearn Street (top right) are the oldest houses on the street (Ethos), which was previously known as W Henry Street as shown on this 1916 Sanborn Map excerpt (*Figure 47*).

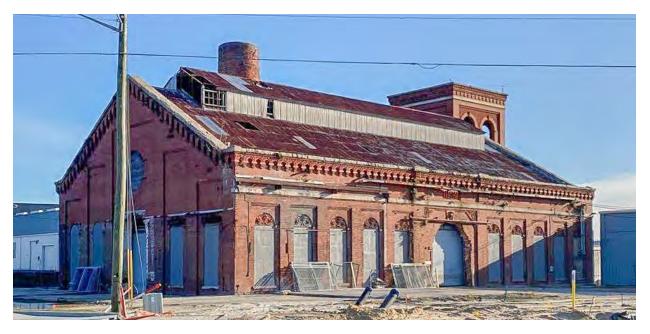
Figure 48: Savannah Water Works Pump House at 1204 W Gwinnett Street built 1892 in the Romanesque Revival style (Ethos).

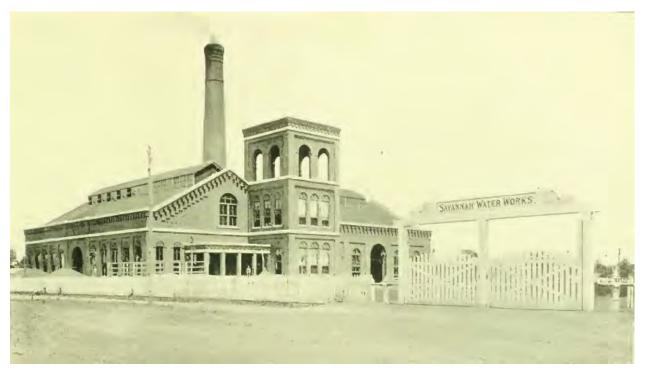
Figure 49: Savannah Water Works Pump House around 1895. The building once had a taller chimney, image looking northwest (Felder).

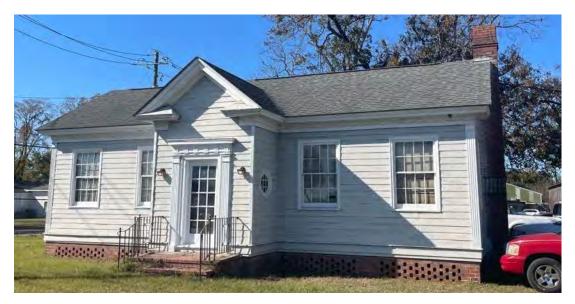
Figure 50: 615 Stiles Avenue built circa 1920 in the Colonial Revival style (Ethos).

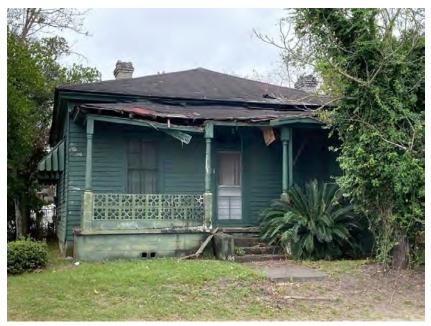
Figure 51: 1002 Stiles Avenue, built circa 1910 as a Center Hall Cottage (Ethos).

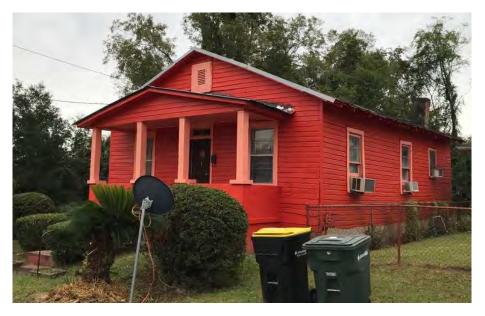
Figure 52: 1111 Springfield Street built circa 1920 as a Front Gable Bungalow (Ethos).

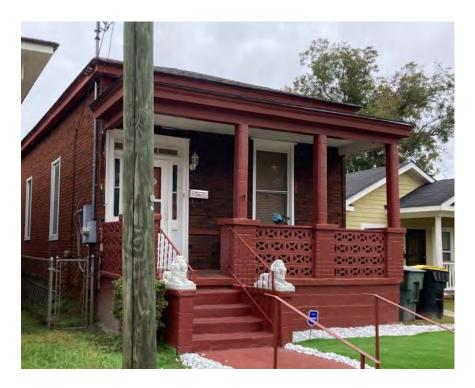
Figure 53: 1112 Springfield Street built circa 1910 as a hip roof Shotgun House (Ethos).

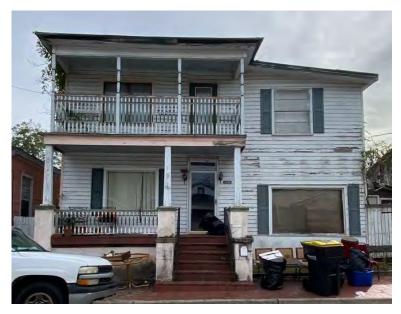
Figure 54: 12 Rothwell Street, the Samuel Fuller Sr. House, built circa 1910 as a two-story Side Hall House with a later two-story shed roof addition (Ethos).

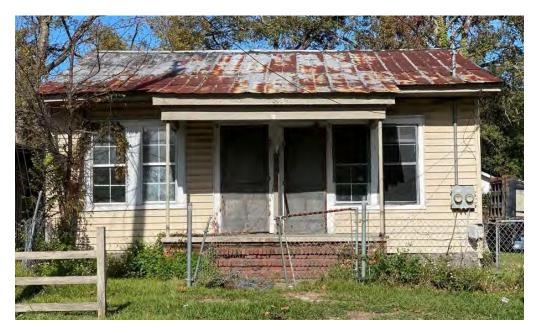
Figure 55: 1406 W Gwinnett Street, built circa 1920 as a Side Gable Duplex (Ethos).

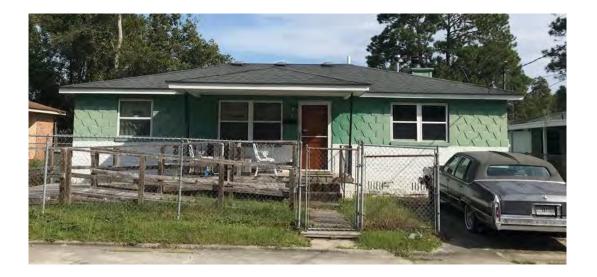
Figure 56: 1004 Hearn Street built circa 1962 as a Linear Ranch house. The house is constructed in stamped concrete block indicative of the Modern Movement (Ethos).

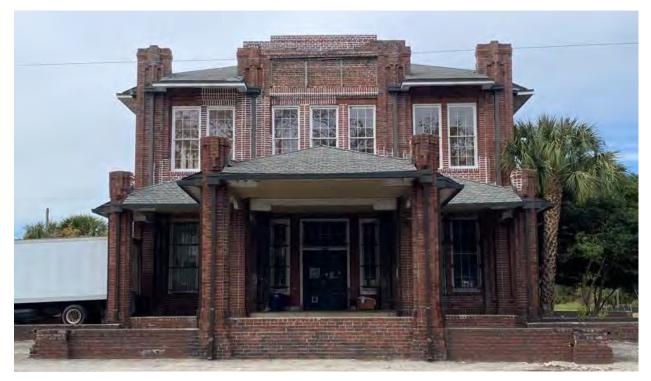
Figure 57: Savannah and Atlanta Railway Office and Transfer Station at 307 Louisville Road built circa 1920 (Ethos).

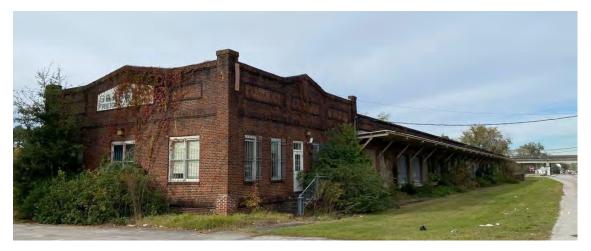
Figure 58: Seaboard Freight Station at 703 Louisville Road, built 1929 (Ethos).

It's important to note that 703 Louisville Road was recently rezoned with conditions, which included allowing the demolition of the historic building. This approval highlights the need for additional preservation measures in the area that contribute to its preservation and limit the erasure of built heritage that tell the story of the area.

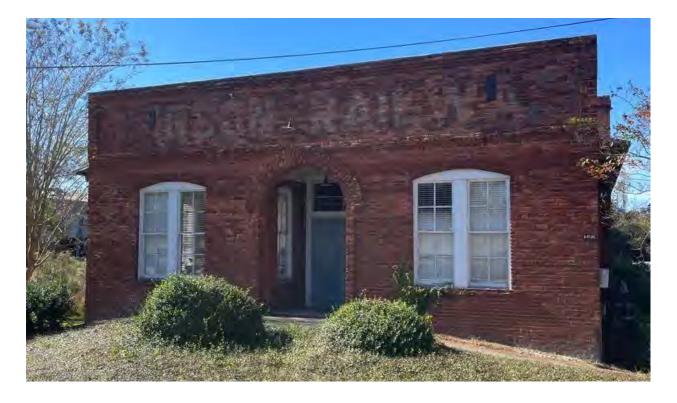
Figure 59: Savannah & Northwestern Railroad Depot Office and Freight Depot, built circa 1910, 415 Boundary Street (Ethos).

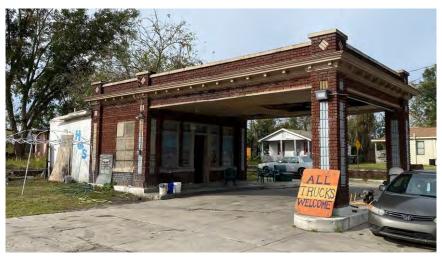
Figure 60: Gulf Service Station built circa 1930 at 62 Louisville Road. Similar station designs for the company can be found throughout the southeast (Ethos).

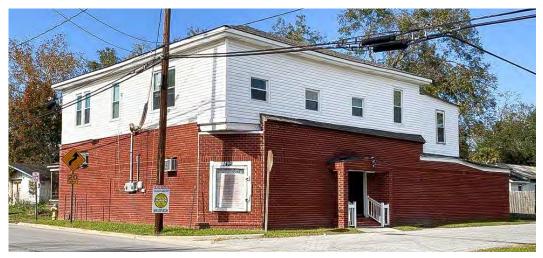
Figure 61: 1402 W Gwinnett Street built circa 1920 as a corner store. The building has been significantly modified and is today being used as a church (Ethos).

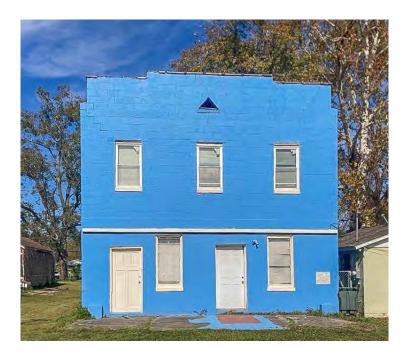
Figure 62: Commercial Building at 1416 W Gwinnett Street built circa 1940 (Ethos).

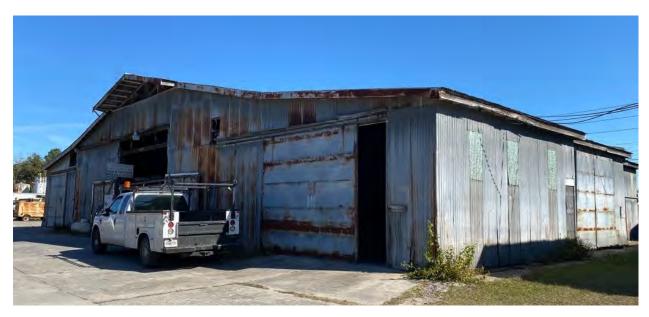
Figure 63: 615 Stiles Avenue built circa 1920 as a warehouse (Ethos).

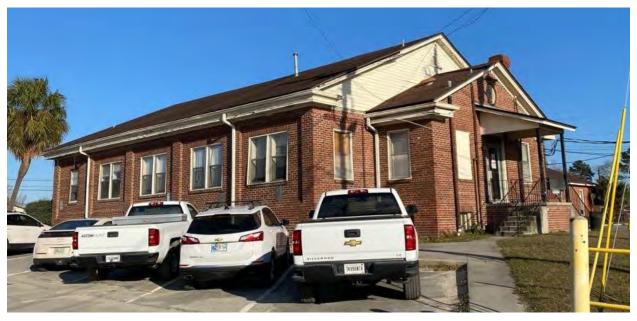
Figure 64: Carter Memorial Laboratory at 702 Stiles Avenue built in 1938 (Ethos).

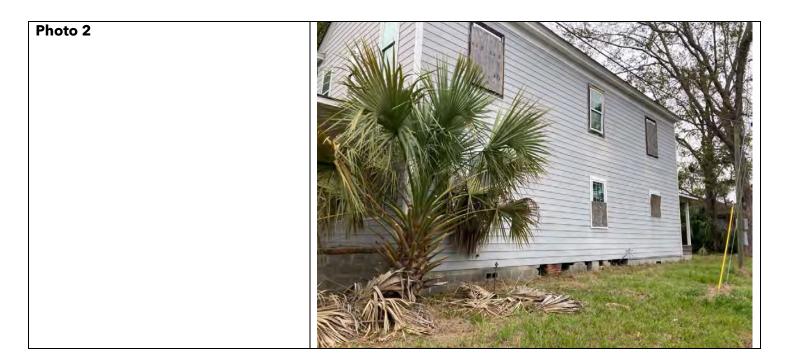
Resource Category	Building
Resource Category Resource Number	40
Property Number	37
Property Number Photo 1

Photo 3	<image/>
Photo 4	
Property Name	
Address	1120 Stiles Avenue
Use (original, subsequent, current)	Residential
Date of Construction	1910
Building Type	Houses
House Type	Single-family House
Single-Family House Type	2 STORY Side Hallway
If Ranch House (select type) Architectural Style	No Acadomic Style
Number of Stories	No Academic Style 2
Roof Type	Gable (cross, front, multi or side)
Roof Material	Asphalt (composition) shingle
Chimney (number of)	1
Chimney Material	
Chimney waterial	Brick

Construction System	Wood
Foundation Type	Pier/PoStreet (with infill)
Foundation Material	Brick
Exterior Material	"Synthetics (vinyl, tarpaper, asbestos, etc)"
Window (Type, pattern, material)	6/6 double hung vinyl
Porch	1 Story front
Porch 2	
Porch Enclosure	
Back Porch (if visible)	Yes 1 Story
Carport and/or Garage Form	
Carport/Garage Status	
Carport/Garage Size	
Carport/Garage Enclosure	
Outbuildings	
Outbuilding Records (type, use,	
exterior material)	
Setting/Grounds Notes	
Additional Notes

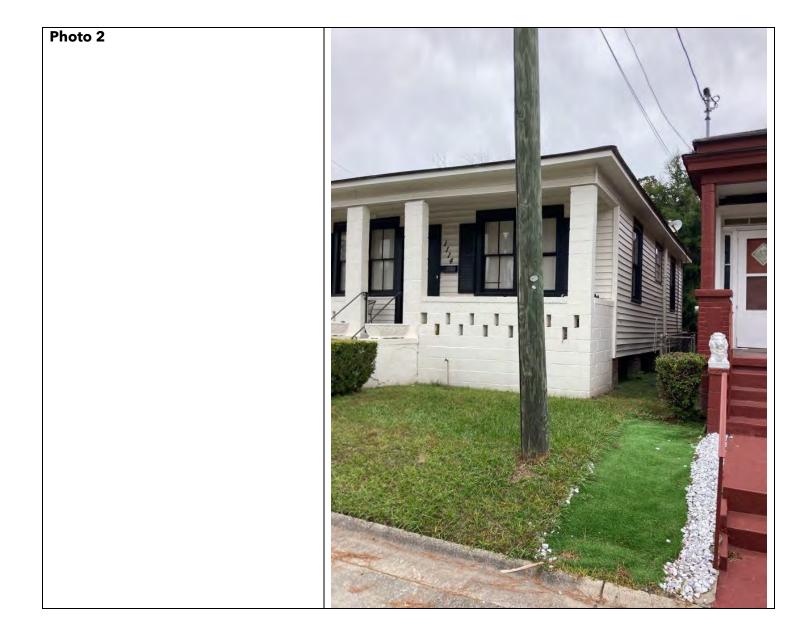
Resource Category	Building
Resource Number	54
Property Number	51
Photo 1

Photo 3	
Photo 4	
Property Name	
Address	1114 Springfield Street
Use (original, subsequent, current)	Residential
Date of Construction	1925
Building Type	Houses
House Type	Single-family House
Single-Family House Type	1 TO 1.5 STORY Bungalow (cross gable, front gable, side gable, or hip)
If Ranch House (select type)	
Architectural Style	No Academic Style
Number of Stories	1
Roof Type	Нір
Roof Material	Asphalt (composition) shingle
Chimney (number of)	1
Chimney Material	Brick
Construction System	Wood
Foundation Type	Pier/Post (no infil)
Foundation Material	Brick
Exterior Material	Concrete, "Synthetics (vinyl, tarpaper, asbestos, etc)"
Window (Type, pattern, material) Porch	2/2 wood double hung, 6/6 double hung vinyl
Porch 2	1 Story front Side Porch
Porch Enclosure	
Back Porch (if visible)	
Carport and/or Garage Form	
Carport/Garage Status	
Carport/Garage Size	
Carport/Garage Enclosure	
Carport Jarage Linciosure

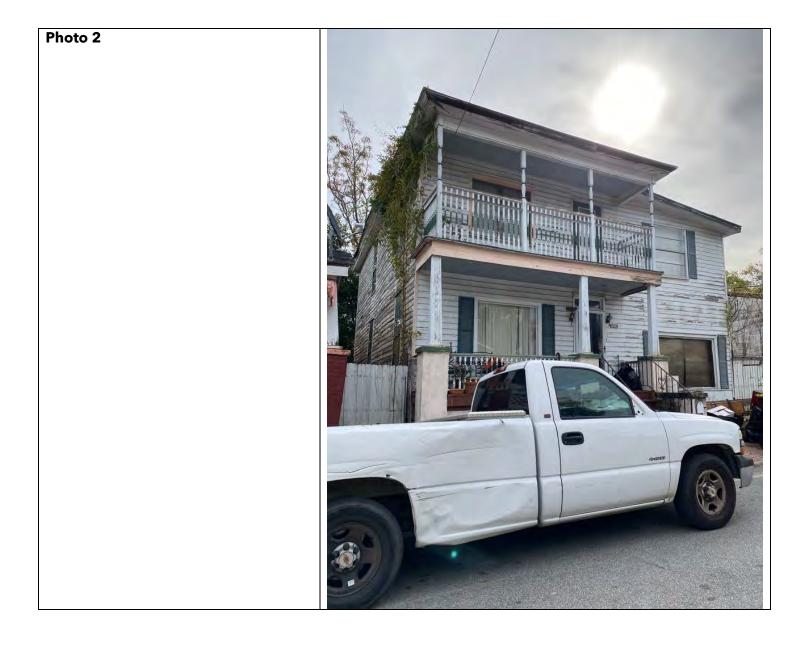
Resource Category	Building
Resource Number	61
Property Number	58
Photo 1

Photo 3	
Photo 3	<image/>
Property Name	Samuel Fuller Sr House
Address	12 and 1/2 Rothwell Street
Use (original, subsequent, current)	Residential
Date of Construction	1910 Houses
Building Type	Houses Single family House
House Type Single Family House Type	Single-family House 2 STORY Side Hallway
Single-Family House Type	
If Ranch House (select type) Architectural Style	No Academic Style
Number of Stories	2
Roof Type	Hip
Roof Material	Asphalt (composition) shingle
Chimney (number of)	0
Chimney Material	
Similey Material

Construction System	Wood
Foundation Type	Pier/PoStreet (with infill)
Foundation Material	Stucco
Exterior Material	Wood
Window (Type, pattern, material)	2:2 wood, variety of picture windows
Porch	2 Story front
Porch 2	
Porch Enclosure	
Back Porch (if visible)	
Carport and/or Garage Form	
Carport/Garage Status	
Carport/Garage Size	
Carport/Garage Enclosure	
Outbuildings	
Outbuilding Records (type, use,	
exterior material)	
Setting/Grounds Notes	
Additional Notes	Addition with shed roof attached. Said to be the Samuel Fuller Jr. House

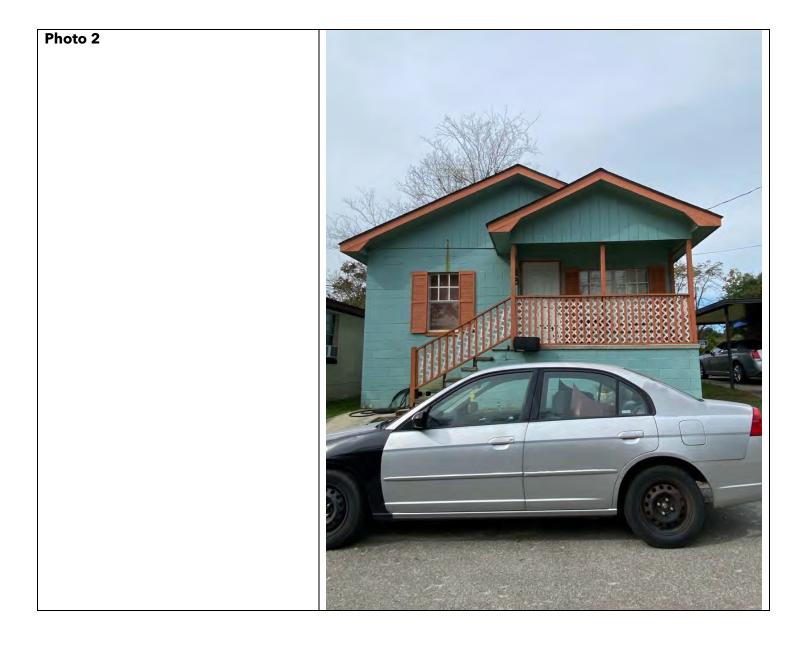
Resource Category	Building
Resource Number	80
Property Number	78
Photo 1	<image/>

Photo 3	<image/>
Photo 4	
Property Name	
Address	13 Brickyard Street
Use (original, subsequent, current)	Residential
Date of Construction	1951
Building Type	Houses
House Type	Single-family House
Single-Family House Type	1 TO 1.5 STORY Bungalow (cross gable, front gable, side gable, or hip)
If Ranch House (select type)	
Architectural Style	No Academic Style
Number of Stories	1
Roof Type	Gable (cross, front, multi or side)
Roof Material	Asphalt (composition) shingle
Chimney (number of)	0
Chimney Material	
Construction System	Masonry
Foundation Type	Continuous
Foundation Material	Concrete Block
Exterior Material	Concrete , Wood
Window (Type, pattern, material)	6:6 vinyl
Porch	1 Story front
Porch 2	
Porch Enclosure	
Back Porch (if visible)	
Carport and/or Garage Form	
Carport/Garage Status	
Carport/Garage Size	
Carport/Garage Enclosure

Outbuildings	
Outbuilding Records (type, use,	
exterior material)	
Setting/Grounds Notes	
Additional Notes	1.5 Story house, raised

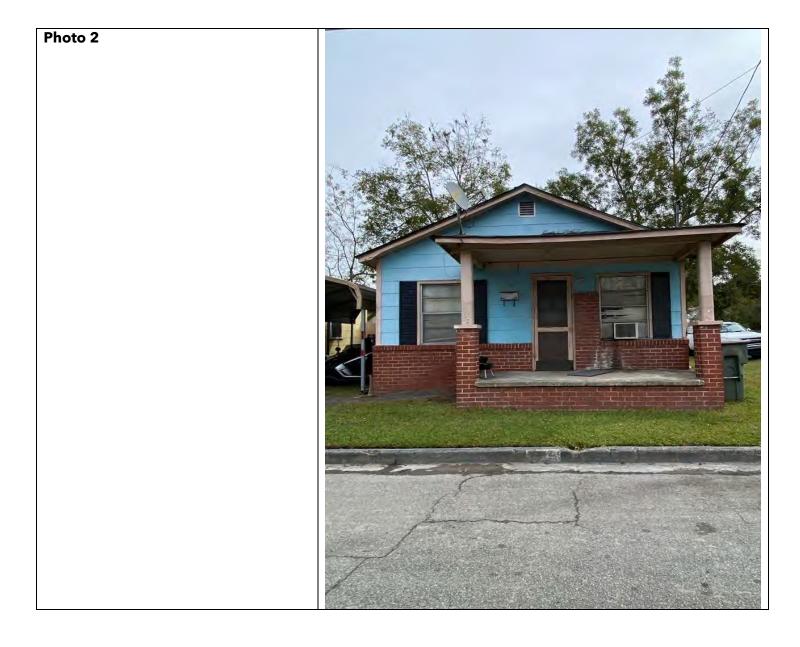
Resource Category	Building
Resource Number	84
Property Number	82
Photo 1

Photo 3	
Photo 4	
Property Name	
Address	14 Brickyard Street
Use (original, subsequent, current)	Residential
Date of Construction	1950
Building Type	Houses
House Type	Single-family House
Single-Family House Type	1 TO 1.5 STORY Bungalow (cross gable, front gable, side gable, or hip)
If Ranch House (select type)	
Architectural Style	No Academic Style
Number of Stories	1
Roof Type	Gable (cross, front, multi or side)
Roof Material	Asphalt (composition) shingle
Chimney (number of)	0
Chimney Material	
Construction System	Masonry
Foundation Type	Continuous
Foundation Material	Concrete Block
Exterior Material	Brick, "Synthetics (vinyl, tarpaper, asbestos, etc)"
Window (Type, pattern, material)	2:2 aluminum
Porch	1 Story front
Porch 2 Porch Enclosure	
Back Porch (if visible)	
Carport and/or Garage Form Carport/Garage Status	
Carport/Garage Status	
Carport/Garage Size	
Carport/Garage Enclosure

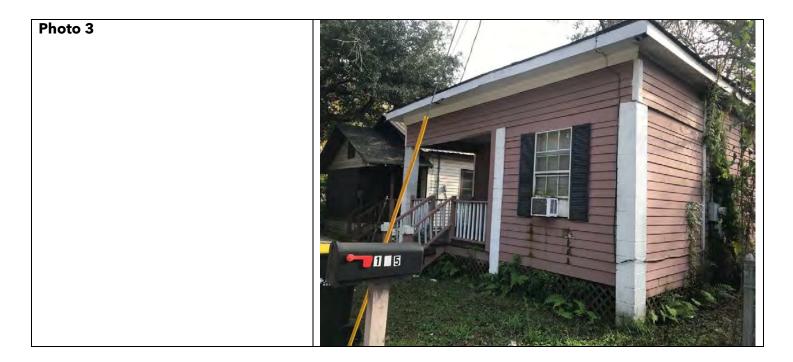
Resource Category	Building 125
Resource Number	125
Property Number	119
Photo 1	
Photo 2

Photo 4	
Property Name	
Address	105 Pitt Street Residential
Use (original, subsequent, current) Date of Construction	1920
	Houses
Building Type	
House Type	Single-family House
Single-Family House Type	1 TO 1.5 STORY Bungalow (cross gable, front gable, side gable, or hip)
If Ranch House (select type)	
Architectural Style	No Academic Style
Number of Stories	1
Roof Type	Нір
Roof Material	Asphalt (composition) shingle
Chimney (number of)	0
Chimney Material

Construction System	Wood
Foundation Type	Pier/Post (no infill)
Foundation Material	Concrete Block
Exterior Material	Wood
Window (Type, pattern, material)	1/1 wood
Porch	1 Story front
Porch 2	
Porch Enclosure	Infilled with walls
Back Porch (if visible)	Yes enclosed with walls
Carport and/or Garage Form	
Carport/Garage Status	
Carport/Garage Size	
Carport/Garage Enclosure	
Outbuildings	
Outbuilding Records (type, use, exterior material)	
•	
Setting/Grounds Notes	
Additional Notes	Half of front porch is enclosed with walls and front door used to be larger or have sidelights and transom

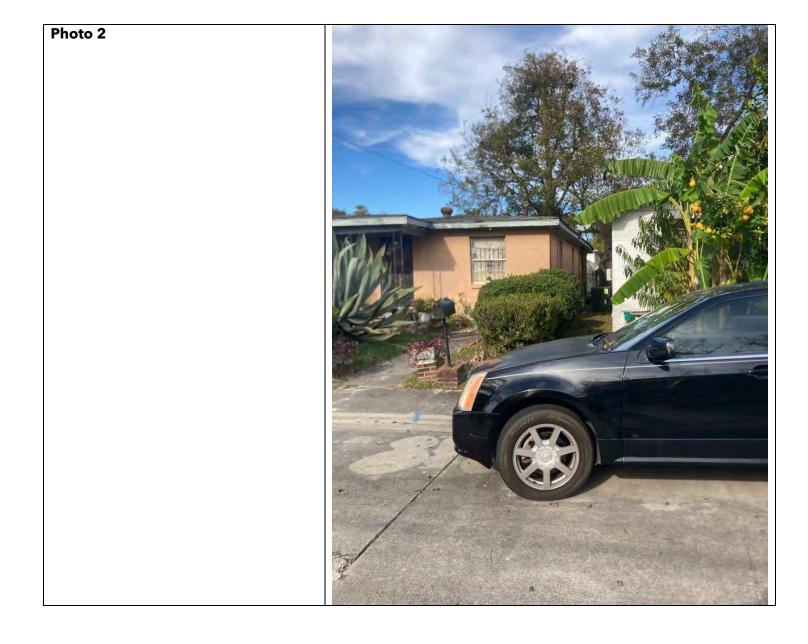
Resource Category	Building
Resource Number	130
Property Number	124
Photo 1

Photo 3	
Photo 4	
Property Name Address	118 Pitt Street
Use (original, subsequent, current)	Residential
Date of Construction	1961
Building Type	Houses
House Type	Single-family House
Single-Family House Type	1 TO 1.5 STORY Ranch House (alphabet, architect designed,
	bungalow ranch, compact, courtyard, linear, rambling)
If Ranch House (select type)	Bungalow ranch
Architectural Style	No Academic Style
Number of Stories	1
Roof Type	Нір
Roof Material	Asphalt (composition) shingle
Chimney (number of)	0
chilliney (humber of)	0

Chimney Material	
Construction System	Masonry
Foundation Type	Continuous
Foundation Material	Concrete Block
Exterior Material	Concrete
Window (Type, pattern, material)	Double hung 2/2 aluminum
Porch	1 Story front
Porch 2	
Porch Enclosure	
Back Porch (if visible)	
Carport and/or Garage Form	
Carport/Garage Status	
Carport/Garage Size	
Carport/Garage Enclosure	
Outbuildings	
Outbuilding Records (type, use,	
exterior material)	
Setting/Grounds Notes	
Additional Notes

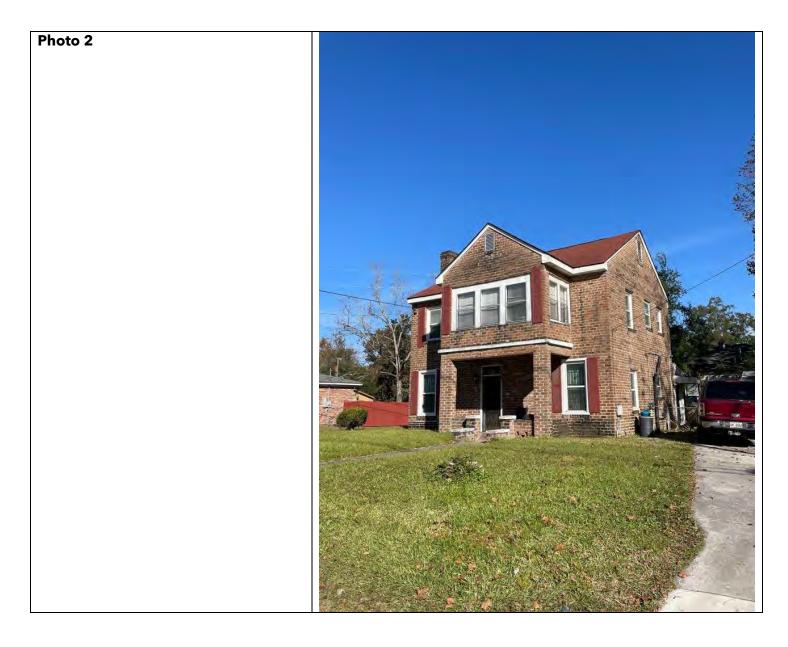
Resource Category	Building
Resource Number	143
Property Number	137
Photo 1

Photo 3	<image/>
Photo 4 Property Name Address	1040 Cornwall Street
	Residential
Use (original, subsequent, current) Date of Construction	1925
Building Type	Houses
House Type	Single-family House
Single-Family House Type	2 STORY Apartment Building
If Ranch House (select type)	
Architectural Style	No Academic Style
Number of Stories	2
Roof Type	Gable (cross, front, multi or side)
Roof Material	Asphalt (composition) shingle
Chimney (number of)	1
Chimney Material	Brick
Construction System	Masonry
Foundation Type	Continuous
Foundation Material	Brick
Exterior Material	Brick
Window (Type, pattern, material)	Double hung sash, vinyl, 1/1
Porch	2 Story front
Porch 2	Side Porch
Porch Enclosure	
Back Porch (if visible)	
Carport and/or Garage Form	
Carport/Garage Status	
Carport/Garage Size	
Carport/Garage Enclosure	
Outbuildings

Outbuilding Records (type, use, exterior material)	
Setting/Grounds Notes	
Additional Notes	Converted to single family dwelling

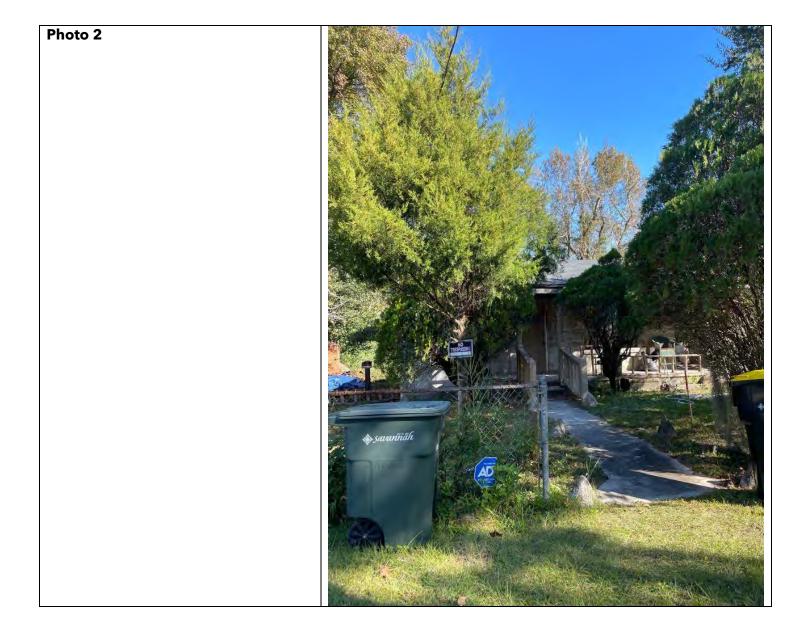
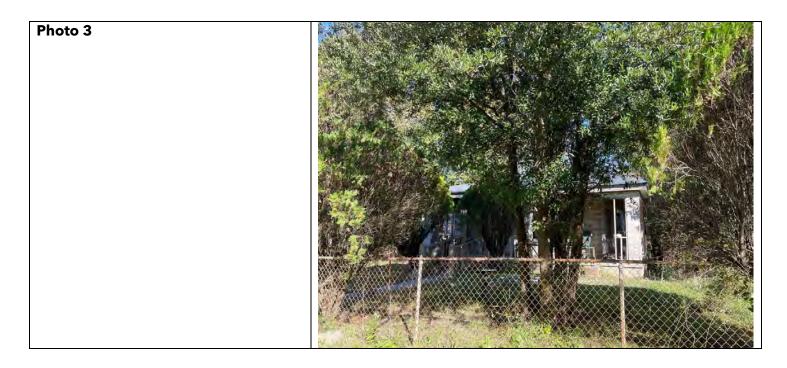
Resource Category	Building
Resource Number	153
Property Number	147
Photo 1

Photo 4	<image/>
Property Name	
Address	1024 Cornwall Street
Use (original, subsequent, current)	Residential
Date of Construction	1950
Building Type	Houses
House Type	Single-family House
Single-Family House Type	1 TO 1.5 STORY Ranch House (alphabet, architect designed, bungalow ranch, compact, courtyard, linear, rambling)
If Ranch House (select type)	Bungalow ranch
Architectural Style	No Academic Style
Number of Stories	1
Roof Type	Нір
Roof Material	Asphalt (composition) shingle
Chimney (number of)	1
Chimney Material	Brick

Construction System	Masonry
Foundation Type	Continuous
Foundation Material	Concrete Block
Exterior Material	Concrete
Window (Type, pattern, material)	Casement, metal, 4/4 Large metal fixed picture windows
Porch	1 Story front, Side Porch
Porch 2	
Porch Enclosure	
Back Porch (if visible)	
Carport and/or Garage Form	
Carport/Garage Status	
Carport/Garage Size	
Carport/Garage Enclosure	
Outbuildings	
Outbuilding Records (type, use,	
exterior material)	
Setting/Grounds Notes	
Additional Notes

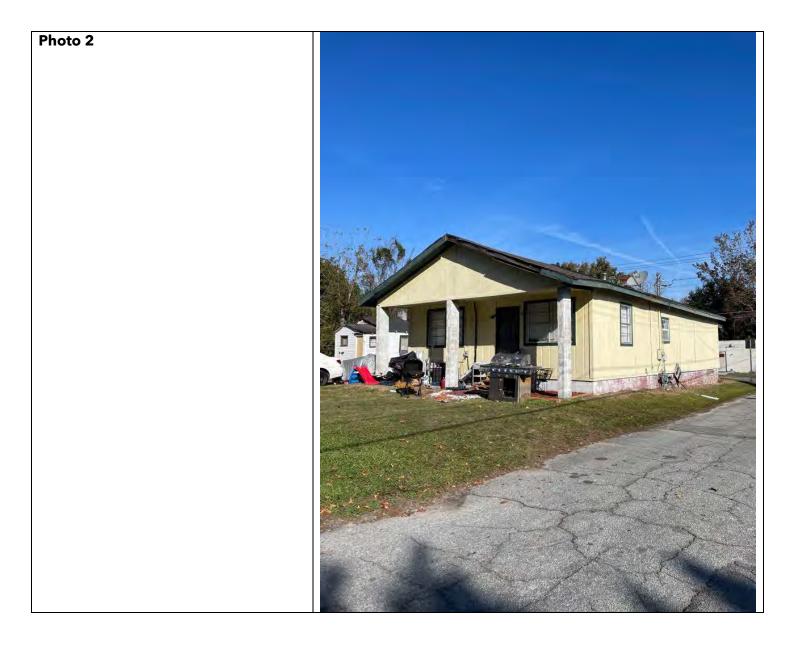
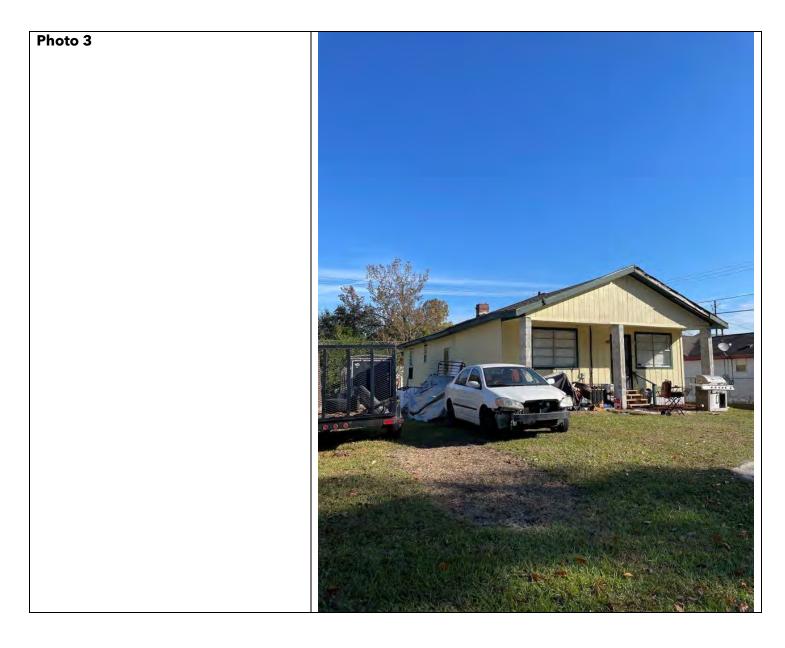
Resource Category	Building
Resource Category Resource Number	154
Property Number	148
Property Number Photo 1

Photo 4	
	<image/>
Property Name	
Address	101 Cornwall Street
Use (original, subsequent, current) Date of Construction	Residential- Single family 1930
Building Type	Houses
House Type	Single-family House
Single-Family House Type	1 TO 1.5 STORY Bungalow (cross gable, front gable, side gable,
	or hip)
If Ranch House (select type)	
Architectural Style	No Academic Style
Number of Stories	1
Roof Type	Gable (cross, front, multi or side)
Roof Material	Steel/Steel alloy (tin)
Chimney (number of)	1
Chimney Material	Brick
	DITCK

Construction System	Wood
Foundation Type	Continuous
Foundation Material	Concrete Block
Exterior Material	Wood
Window (Type, pattern, material)	Double hung sash, aluminum, 2/2 double hung sash, vinyl, 1/1
Porch	1 Story front
Porch 2	
Porch Enclosure	
Back Porch (if visible)	
Carport and/or Garage Form	
Carport/Garage Status	
Carport/Garage Size	
Carport/Garage Enclosure	
Outbuildings	
Outbuilding Records (type, use,	
exterior material)	
Setting/Grounds Notes	
Additional Notes

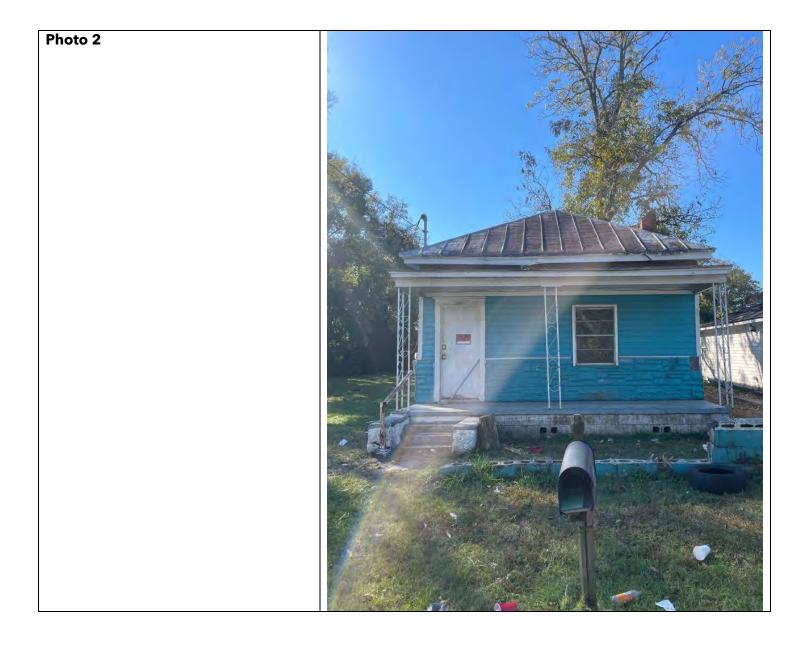
Resource Category	Building
Resource Category Resource Number	160
Property Number	154
Property Number Photo 1

Photo 3	
	<image/>
Photo 4	
Property Name	
Address	25 Cornwall Street
Use (original, subsequent, current) Date of Construction	Residential 1910
Building Type	Houses Single family House
House Type	Single-family House
Single-Family House Type	1 TO 1.5 STORY Shotgun
If Ranch House (select type)	No Acadomia Stula
Architectural Style	No Academic Style
Number of Stories	
Roof Type	Hip Steal/Steal-allow (tin)
Roof Material	Steel/Steel alloy (tin)
Chimney (number of)	2
Chimney Material	Brick

Construction System	Wood
Foundation Type	Pier/Post (no infill)
Foundation Material	Concrete Block
Exterior Material	Wood, "Synthetics (vinyl, tarpaper, asbestos, etc)"
Window (Type, pattern, material)	Double hung sash, aluminum, 2/2
Porch	1 Story front
Porch 2	
Porch Enclosure	
Back Porch (if visible)	
Carport and/or Garage Form	
Carport/Garage Status	
Carport/Garage Size	
Carport/Garage Enclosure	
Outbuildings	
Outbuilding Records (type, use,	
exterior material)	
Setting/Grounds Notes	
Additional Notes

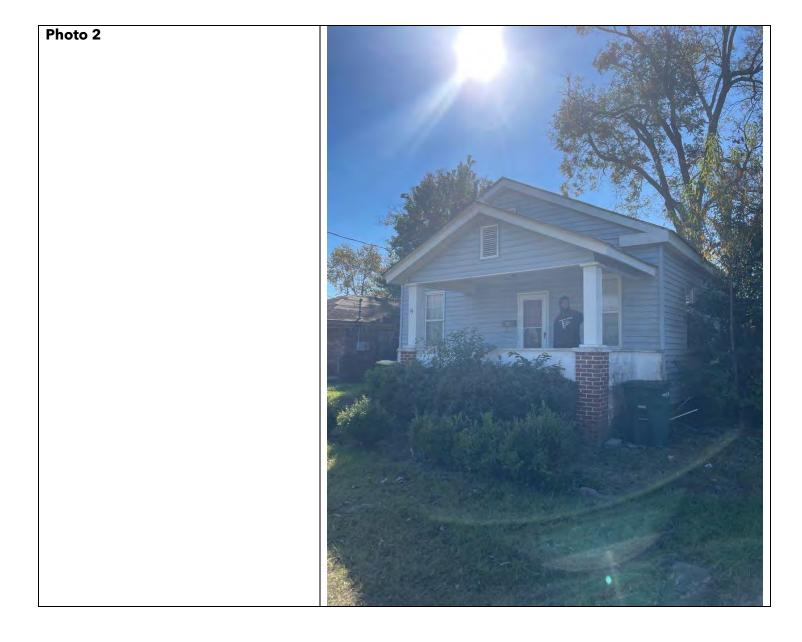
Resource Category	Building
Resource Number	161
Property Number	155
Property Number Photo 1

Photo 3	
Photo 4	
Property Name	
Address	19 Cornwall Street
Use (original, subsequent, current)	Residential
Date of Construction	1930
Building Type	Houses
House Type	Single-family House
Single-Family House Type	1 TO 1.5 STORY Bungalow (cross gable, front gable, side gable, or hip)
If Ranch House (select type)	
Architectural Style	No Academic Style
Number of Stories	1
Roof Type	Gable (cross, front, multi or side)
Roof Material	Asphalt (composition) shingle
Chimney (number of)	0
	V

Chimney Material	
Construction System	Wood
Foundation Type	Continuous
Foundation Material	Concrete Block
Exterior Material	"Synthetics (vinyl, tarpaper, asbestos, etc)"
Window (Type, pattern, material)	Double hung sash, vinyl, 1/1
Porch	1 Story front
Porch 2	
Porch Enclosure	
Back Porch (if visible)	
Carport and/or Garage Form	
Carport/Garage Status	
Carport/Garage Size	
Carport/Garage Enclosure	
Outbuildings	
Outbuilding Records (type, use,	
exterior material)	
Setting/Grounds Notes	
Additional Notes	Very altered in materiality
