Canal District Historic and Cultural Resources Report

In 2021, the City of Savannah solicited proposals to identify historically significant structures, development patterns, and neighborhood boundaries; and provide documentation and recommendations for the protection of historic resources within the Canal District (Figure 1). Ethos Preservation, a local, women-owned small business, was selected to complete the project. This report builds upon efforts previously undertaken by the City of Savannah as part of the Canal District Master Plan, where the need for a cultural and historic resource survey of the area was identified to support: 1) the reuse of the Water Works building as a community market and business center (Action Step 7); 2) the curation and construction of the West Savannah Heritage Trail (Action Step 8); and 3) the revision of the Zoning Ordinance to establish a Canal District Overlay District (Action Step 18).

The bounds of the study area were determined by the community-selected boundaries established in the Canal District Master Plan. Of the 335 buildings within the study area, 192 were determined to be 40 years or older and were subsequently documented through th

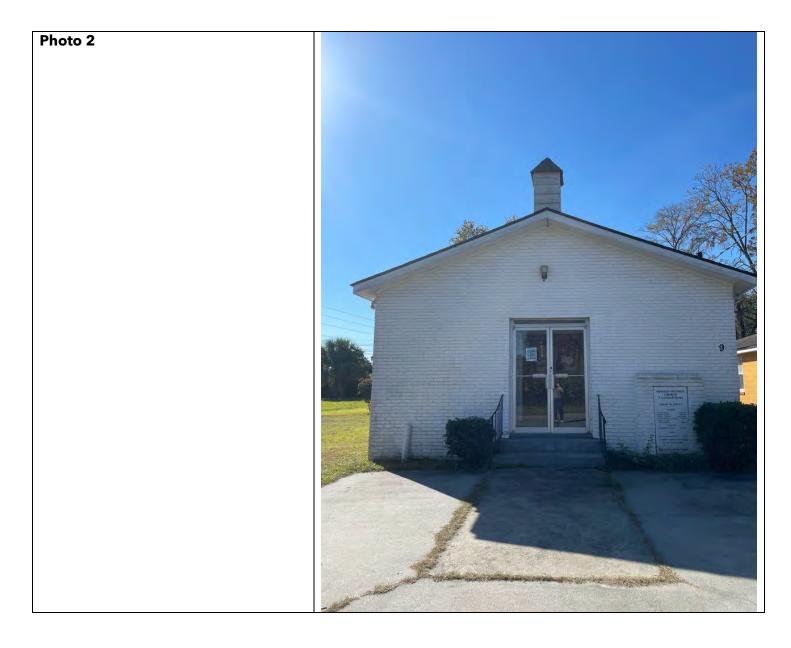
Resource Category	Building
Resource Number	163
Property Number	157
Photo 1

Photo 3	
Photo 4	
Property Name	Antioch Holiness Church
Address	9 Cornwall Street
Use (original, subsequent, current)	Church
Date of Construction	1955
Building Type	Churches/ Places of Worship
House Type	
Single-Family House Type	
If Ranch House (select type)	
Architectural Style	No Academic Style
Number of Stories	
Roof Type Roof Material	Gable (cross, front, multi or side)
Chimney (number of)	Asphalt (composition) shingle
Chimney (humber of) Chimney Material	Concrete block
Construction System	Masonry
Foundation Type	Continuous
Foundation Material	Concrete Block
Exterior Material	Brick, Concrete
Window (Type, pattern, material)	Awning, aluminum, 4 panes Double hung, aluminum, 2/2 Double hung, vinyl, 1/1
Porch	1 Story front
Porch 2	Side Porch
Porch Enclosure	
Back Porch (if visible)	
Carport and/or Garage Form	
Carport/Garage Status	
Carport/Garage Size

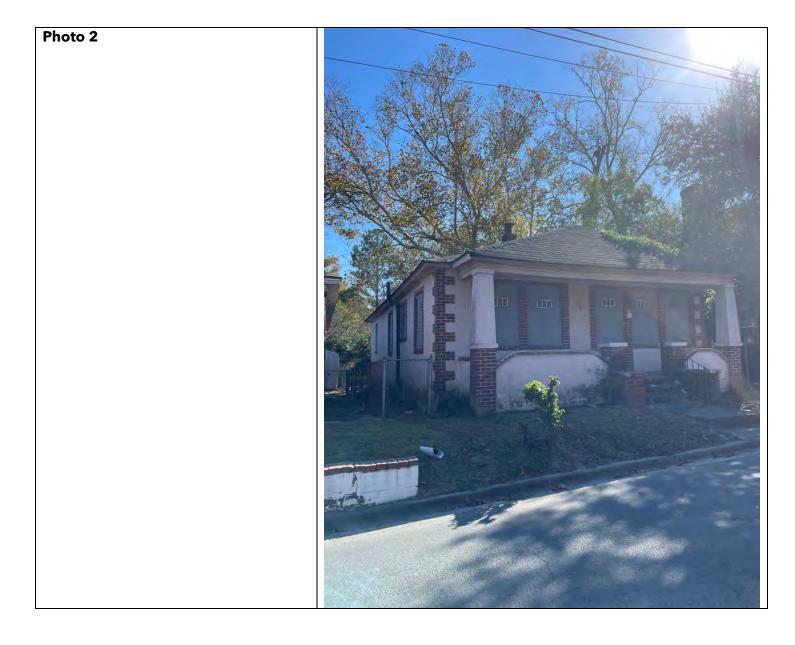
Resource Category	Building
Resource Number	164
Property Number	158
Photo 1

Photo 3	
	<image/>
Photo 4	
Property Name	
Address	618 Magazine Avenue
Use (original, subsequent, current)	Residential, vacant
Date of Construction	1948
Building Type	Houses
House Type	Single-family House
Single-Family House Type	1 TO 1.5 STORY Bungalow (cross gable, front gable, side gable, or hip)
If Ranch House (select type)	
Architectural Style	No Academic Style
Number of Stories	1
Roof Type	Нір
Roof Material	Asphalt (composition) shingle
Chimney (number of)	1
Chimney Material	Brick
Construction System	Masonry
Foundation Type	Continuous
Foundation Material	Concrete Block
Exterior Material	Concrete
Window (Type, pattern, material)	Boarded
Porch Porch 2	1 Story front
Porch 2 Porch Enclosure	
Back Porch (if visible)	
Carport and/or Garage Form	
Carport and/or Garage Form Carport/Garage Status	
Carport/Garage Size	
Carport/Garage Enclosure	
Carport Garage Eliciosure

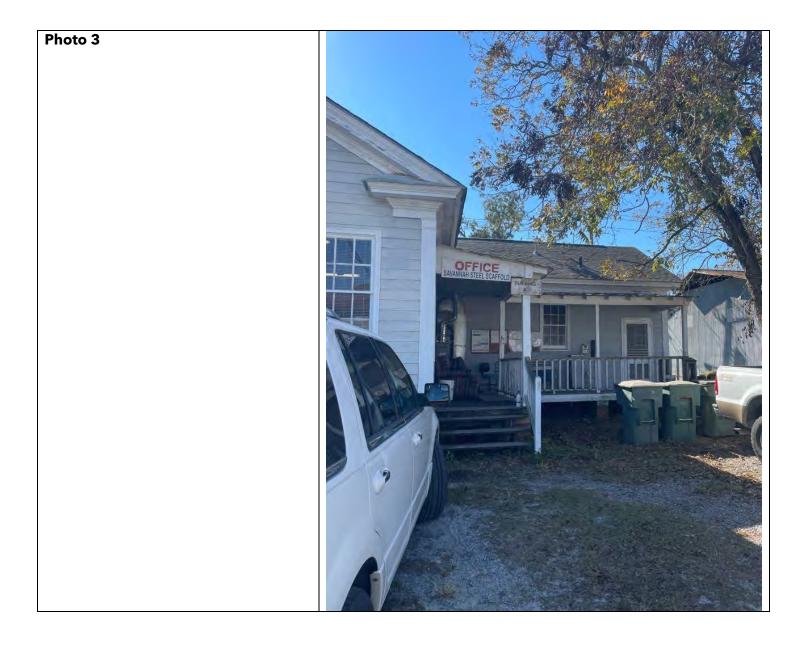
Resource Category	Building 173
Resource Number	173
Property Number	166
Photo 1	
Photo 2	<image/>

Photo 4	<image/>
Property Name	Office - Savannah Steel Scaffold
Address	615 Stiles Avenue
Use (original, subsequent, current)	Office
Date of Construction	1941
Building Type	Commercial Buildings (retail & office)
House Type	
Single-Family House Type	
If Ranch House (select type)	
Architectural Style	Colonial Revival
Number of Stories	1
Roof Type	Gable (cross, front, multi or side)
Roof Material	Asphalt (composition) shingle
Chimney (number of)	1
Chimney Material	Brick
Construction System	Wood
Foundation Type	Continuous
Foundation Material	Brick
Exterior Material	Wood
Window (Type, pattern, material)	Double hung sash, wood 6/6 and 8/8
Porch	1 Story front
Porch 2	
Porch Enclosure	
Back Porch (if visible)	L shape, wood with exposed tails
Carport and/or Garage Form	
Carport/Garage Status	
Carport/Garage Size	
Carport/Garage Enclosure	
Outbuildings

Outbuilding Records (type, use, exterior material)	
Setting/Grounds Notes	
Additional Notes	Man inside confirmed date and use.

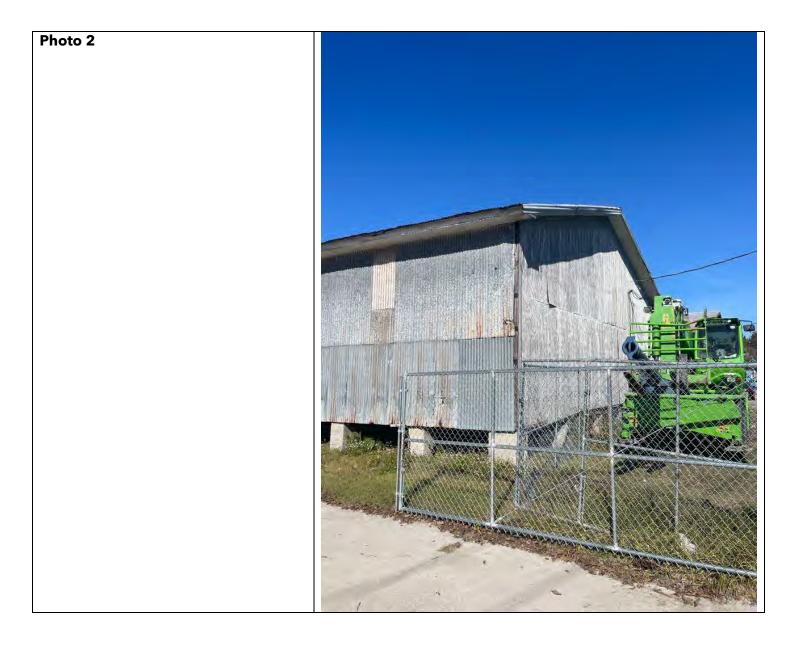
Resource Category	Building
Resource Number	176
Property Number	166
Photo 1

Photo 3	
Photo 4	
Property Name	JP Grant Company
Address	615 Stiles Avenue
Use (original, subsequent, current)	Manufacturing, vacant
Date of Construction	1950
Building Type	Industrial Buildings
House Type	
Single-Family House Type	
If Ranch House (select type)	
Architectural Style	No Academic Style
Number of Stories	1
Roof Type	Gable (cross, front, multi or side)
Roof Material	Steel/Steel alloy (tin)
Chimney (number of)	0
Chimney Material	
Construction System	Wood
Foundation Type Foundation Material	Pier/Post (no infil)
Exterior Material	Concrete Block Metal
	Two bay wood garage doors on side
Window (Type, pattern, material) Porch	Side Porch
Porch 2	
Porch Enclosure	
Back Porch (if visible)	
Carport and/or Garage Form	
Carport/Garage Status	
Carport/Garage Size	
Carport/Garage Enclosure	
Outbuildings

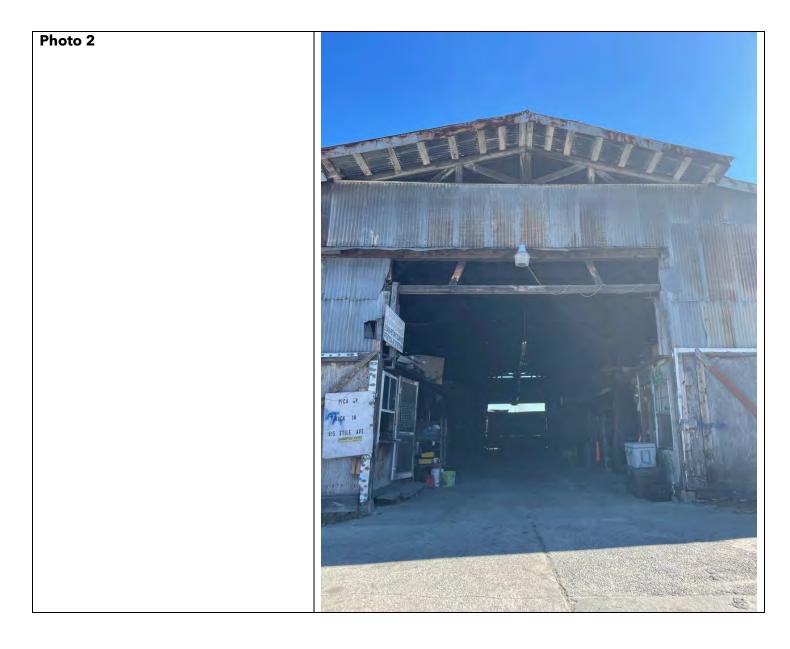
Resource Category	Building
Resource Number	177
Property Number	166
Photo 1	<image/>

Photo 3	
	UGHES ALL OMPANY
	COLDARGE ASSIGNERS
Photo 4	
Property Name	Savannah Steel Scaffolding Warehouse
Address	615 Stiles Avenue
Use (original, subsequent, current)	Warehouse
Date of Construction	1950
Building Type	Industrial Buildings
House Type	
Single-Family House Type	
If Ranch House (select type)	
Architectural Style	No Academic Style
Number of Stories	
Roof Type	Gable (cross, front, multi or side)
Roof Material	Steel/Steel alloy (tin)
Chimney (number of)	0
Chimney Material Construction System	Wood
Foundation Type	Slab
Foundation Material	Concrete poured
Exterior Material	Metal
Window (Type, pattern, material)	N/A
Porch	
Porch 2	
Porch Enclosure	
Back Porch (if visible)	
Carport and/or Garage Form	
Carport/Garage Status	
Carport/Garage Size	
Carport/Garage Enclosure	
Outbuildings

Outbuilding Records (type, use, exterior material)	
Setting/Grounds Notes	
Additional Notes	Historic sign says Hughes Ball Company "happy building
	customers"
